**CWA COMPLIANCE EVALUATION INSPECTION REPORT
U.S. ENVIRONMENTAL PROTECTION AGENCY, REGION 5**

Compliance Evaluation Sampling Inspection

Walworth County

November 17, 2015

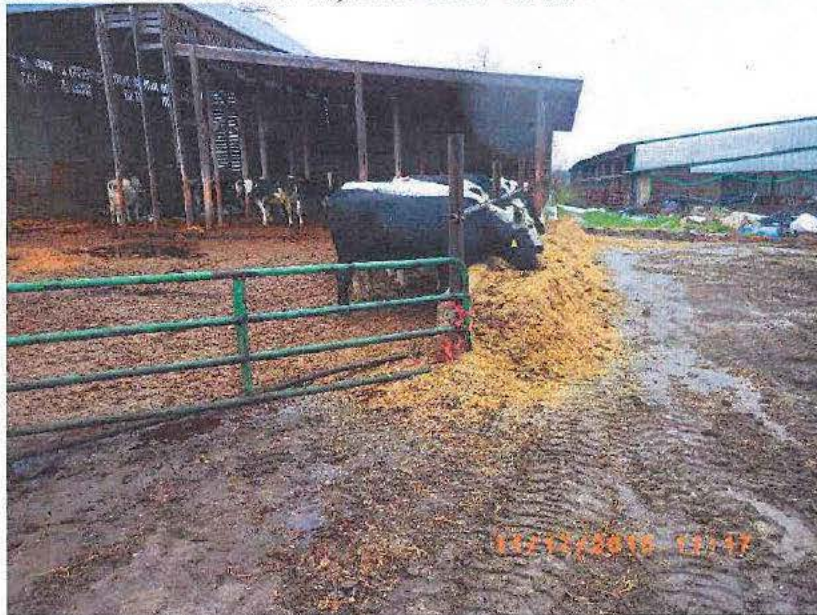
3: RIMG0555

Description: Even though feed is hauled away daily, the feed placed on the ground outside the pen is exposed to precipitation. There are no gutters on the barn roof.

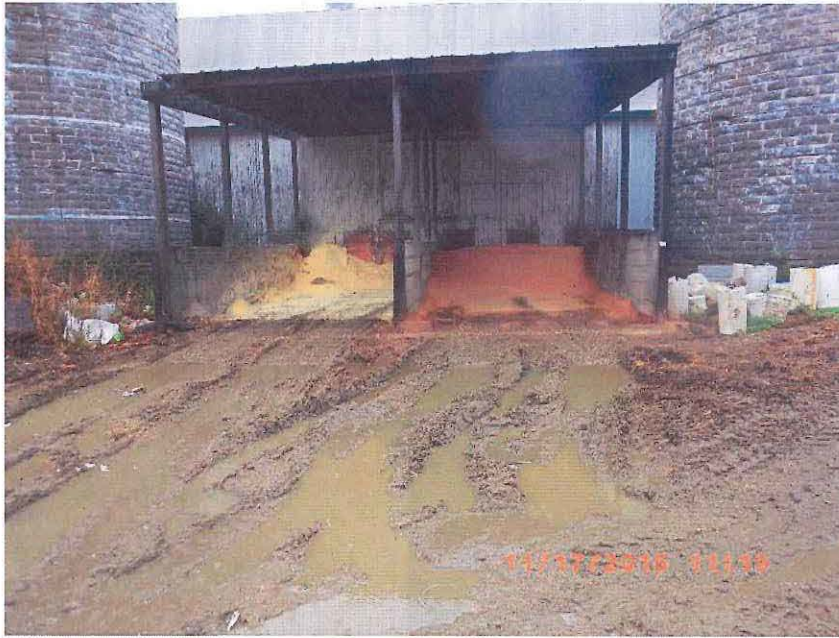
4: RIMG0556

Description: Small amount of commodities (protein and hominy) is lost to precipitation from the open bays.

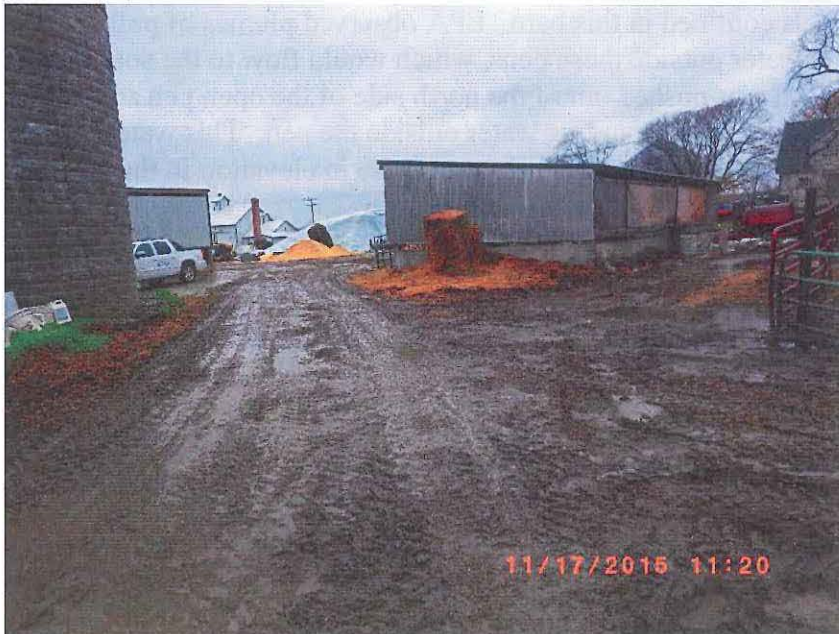
5: RIMG0557

Description: Raw materials stored out in the open on east side of Calf Barn.

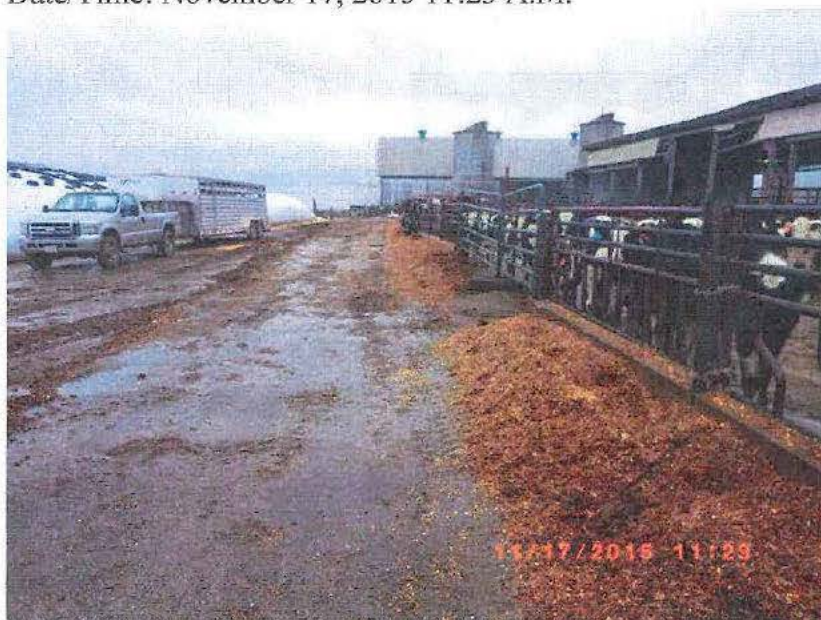
10: RIMG0562

Description: Feed for the heifer pens is piled on the ground outside the pens. Without being covered, the feed and process wastewater from the feed could flow with precipitation to the south.

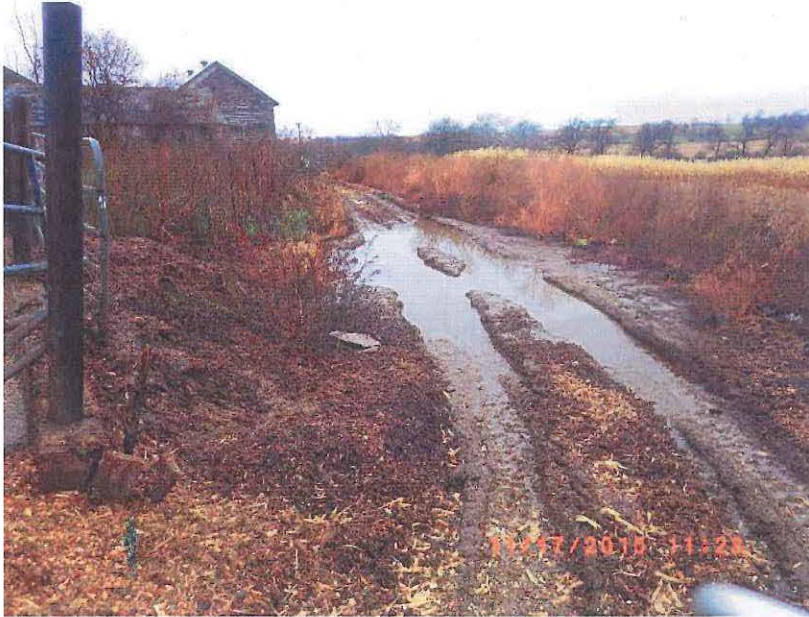
11: RIMG0563

Description: Feed, manure and process wastewater from the north side of the open pens of the Heifer Barn discharge onto the access road. EPA did not observe them going into a surface water. Steers in the pen at the end of the road prevented EPA from inspecting any closer.

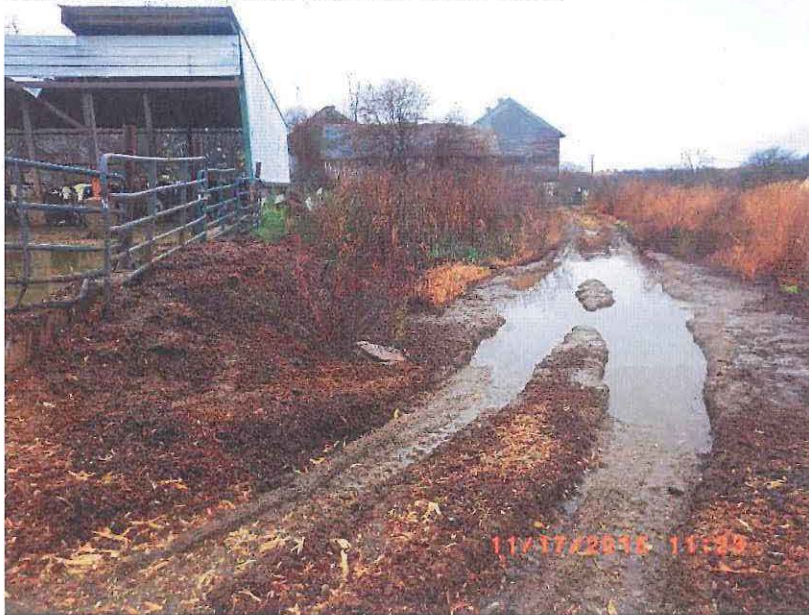
12: RIMG0564

Description: Feed, manure and process wastewater from the north side of the open pens of the Heifer Barn discharge onto the access road.

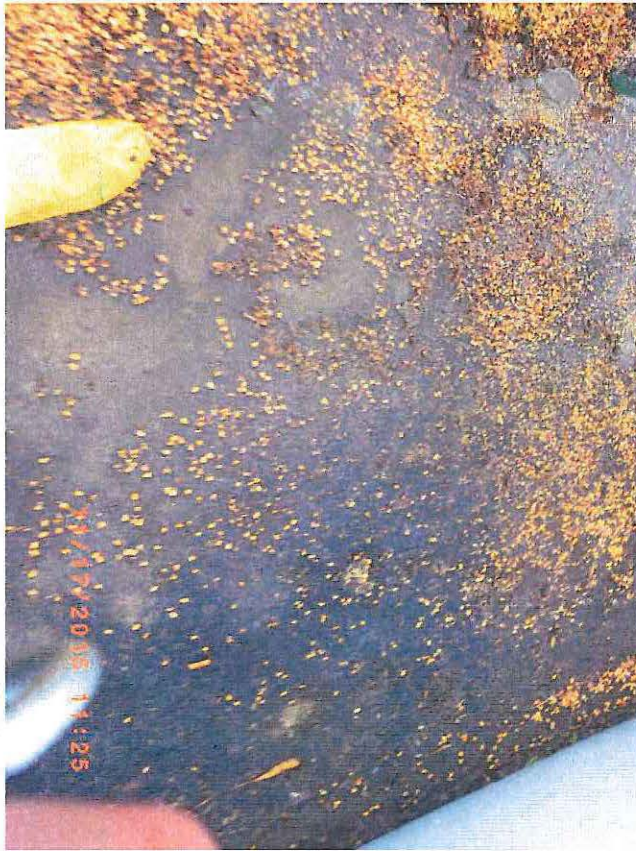
13: RIMG0565

Description: Spilled feed from the Silage Pad was in the standing water off of the pad.

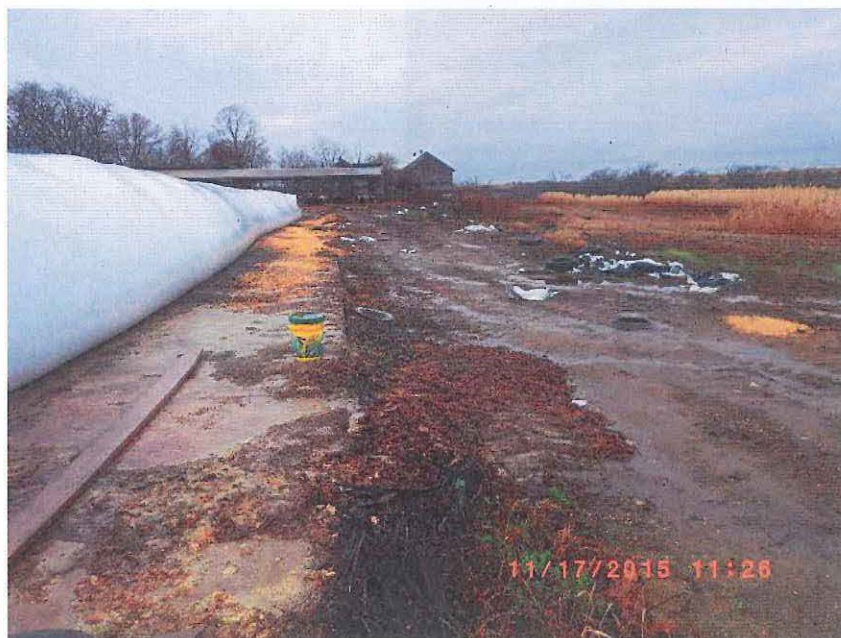
15: RIMG0567

Description: Spilled feed on and around the Silage Pad.

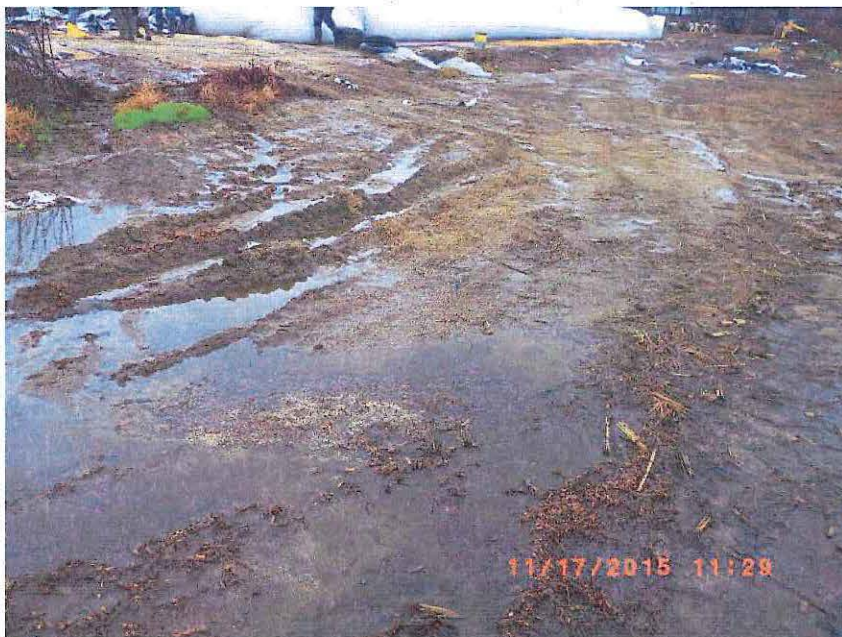
17: RIMG0569

Description: Silage was not contained on the Silage Pad.

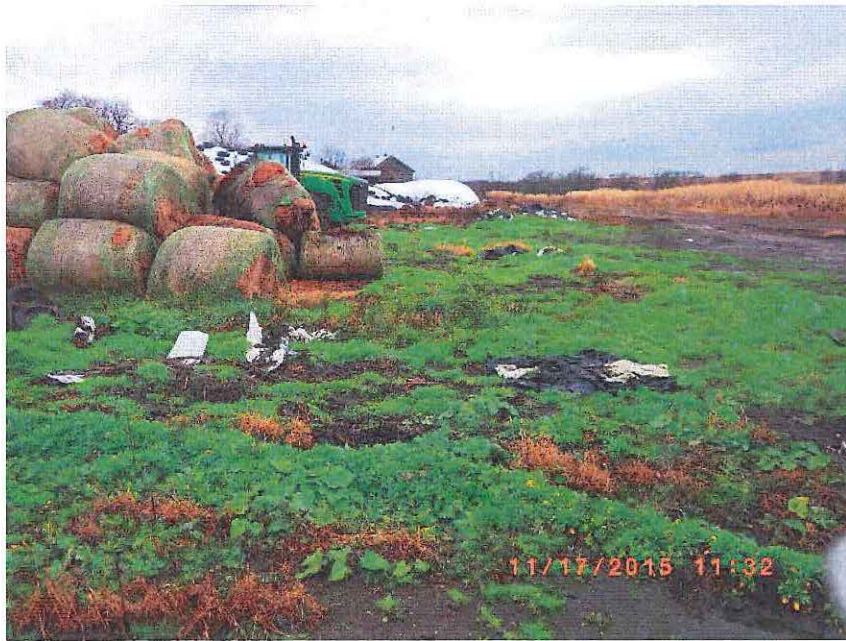
Description: EPA observed spilled feed and process wastewater from spilled feed on and around the Silage Pad.

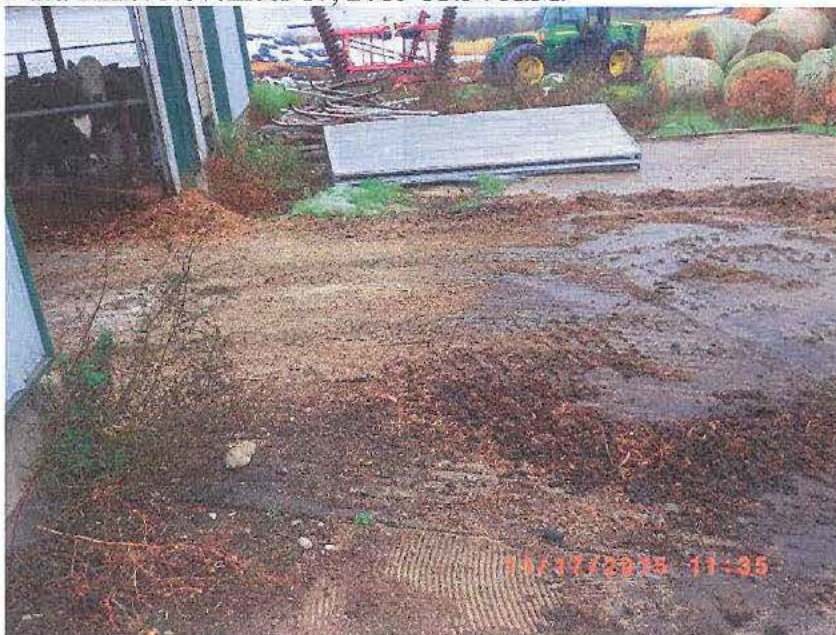
22: RIMG0574

Description: Track in and track out of manure and feed at the northeast end of the 2010 Freestall Barn. The manure and feed could be transported with precipitation to the east.

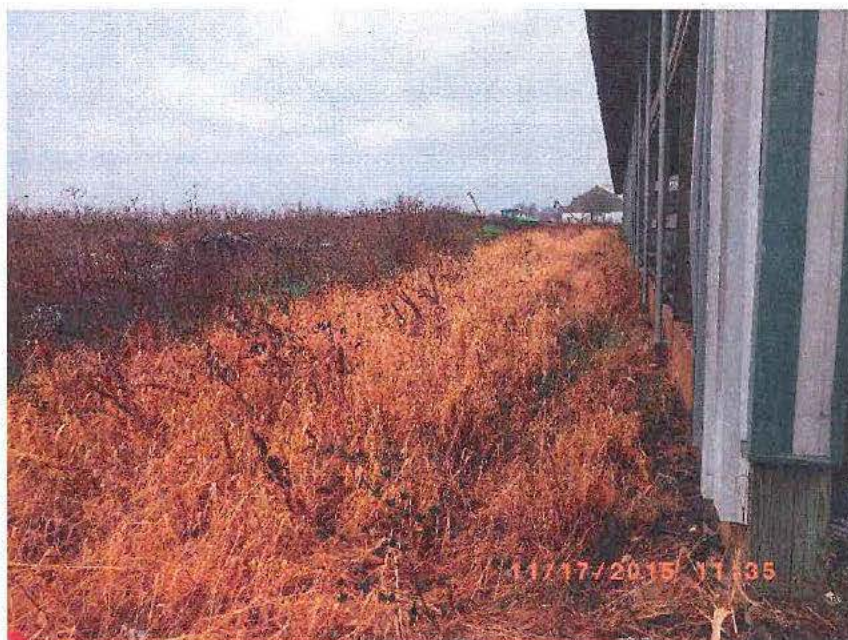
23: RIMG0575

Description: Scrap and garbage are piled in the field to the east of the 2010 Freestall Barn.

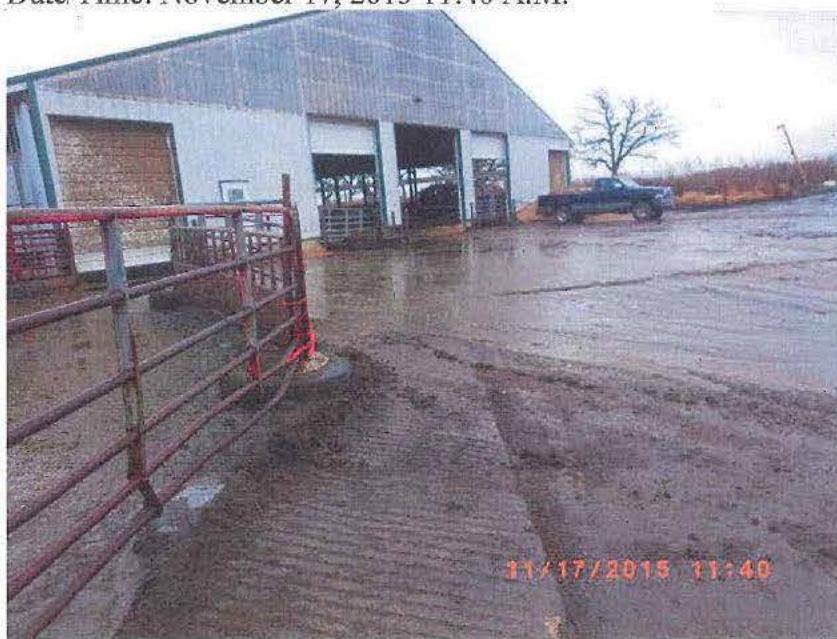
26: RIMG0578

Description: Track in and track out of manure and process wastewater from the southwest side of the 2010 Freestall Barn would flow with precipitation to the Manure Pond.

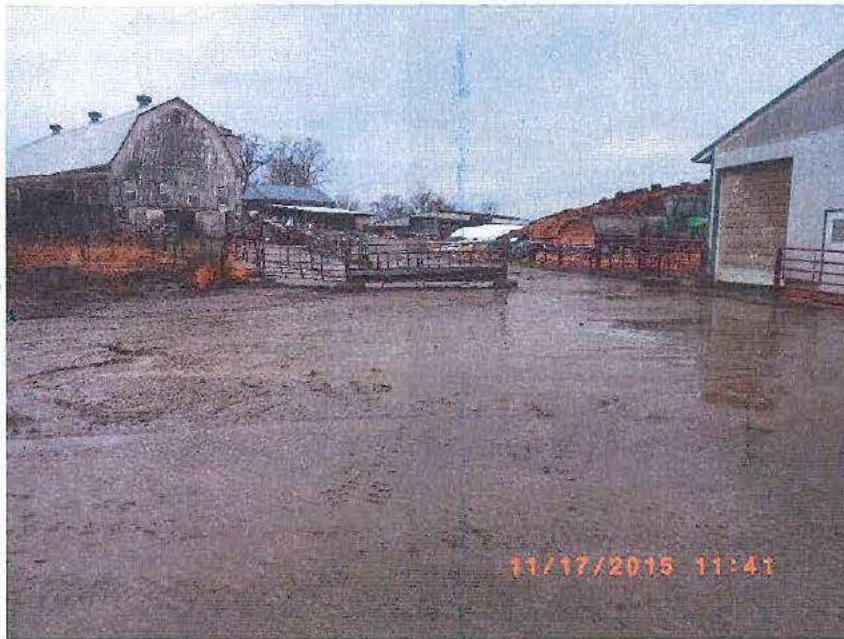
27: RIMG0579

Description: East side of the Milking Parlor. Track in and track out would flow with precipitation to the Manure Pond.

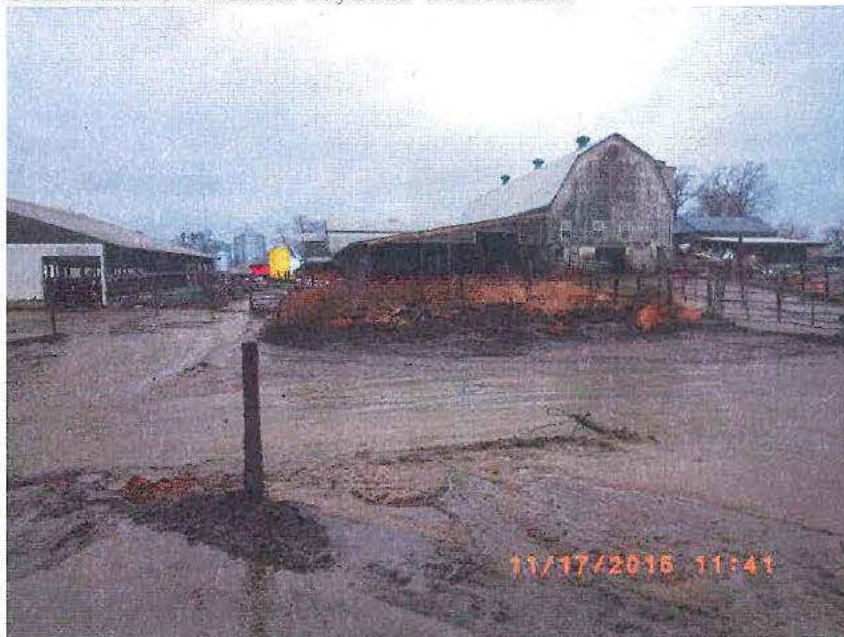
28: RIMG0580

Description: East side of the Milking Parlor and freestall barn to the left (south). Track in and track out would flow with precipitation to the Manure Pond.

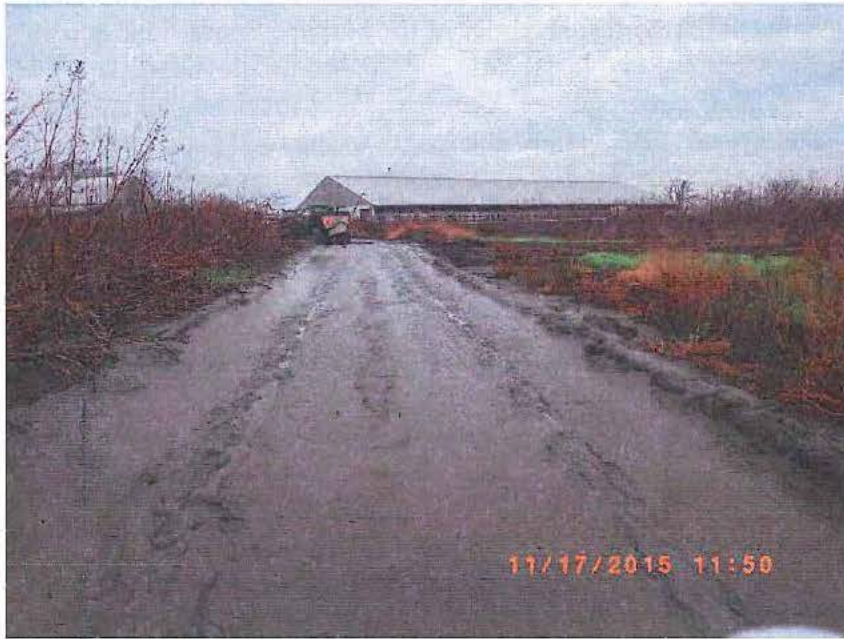
30: RIMG0582

Description: Manure is several inches deep on access road to crop field to the south.

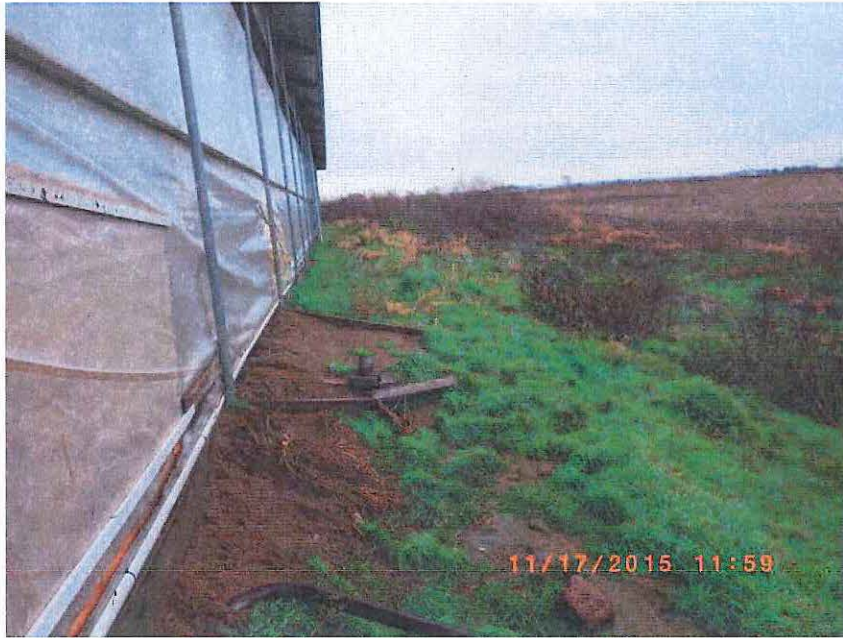
34: RIMG0586

Description: Sand pushed out on the south side of the 2004 Freestall Barn.

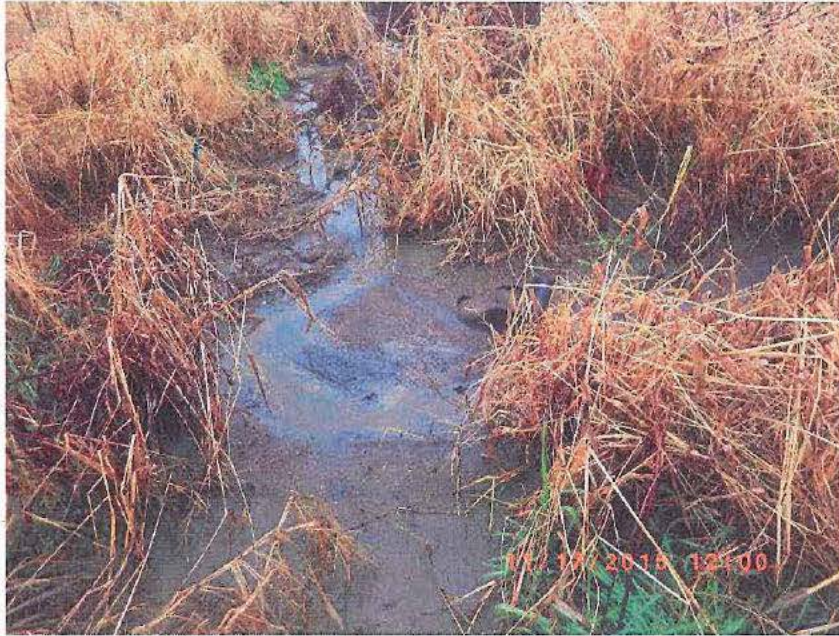
35: RIMG0587

Description: A drainage ditch on the south side of the facility conveyed flow to the west.

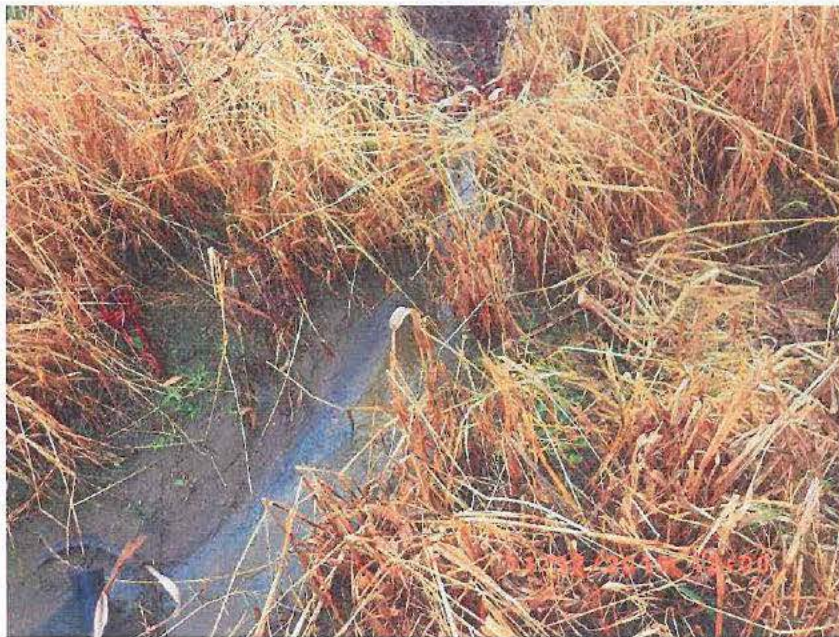
36: RIMG0588

Description: A drainage ditch on the south side of the facility conveyed flow to the west.

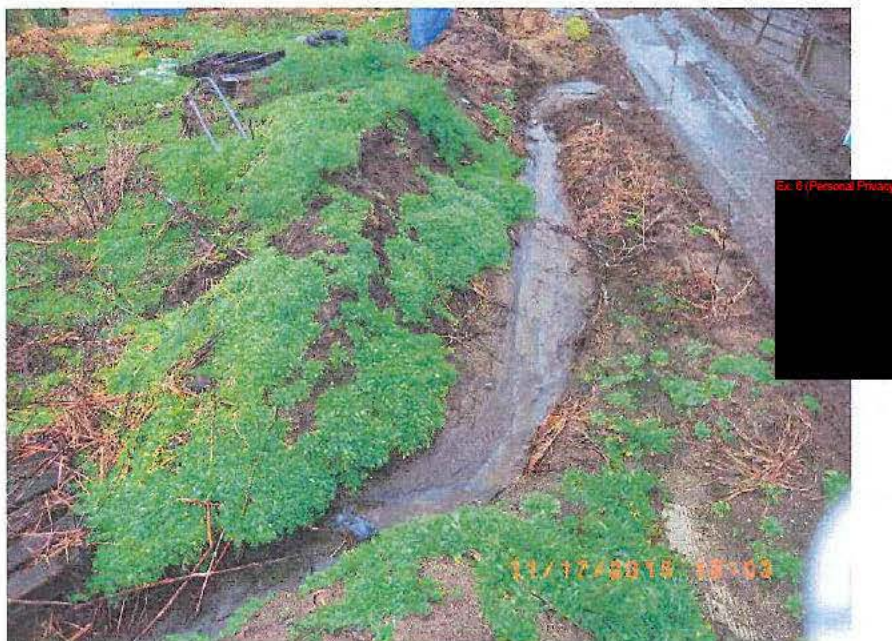
44: RIMG0596

Description: Flow from the access road channelized and flowed south to the drainage ditch.

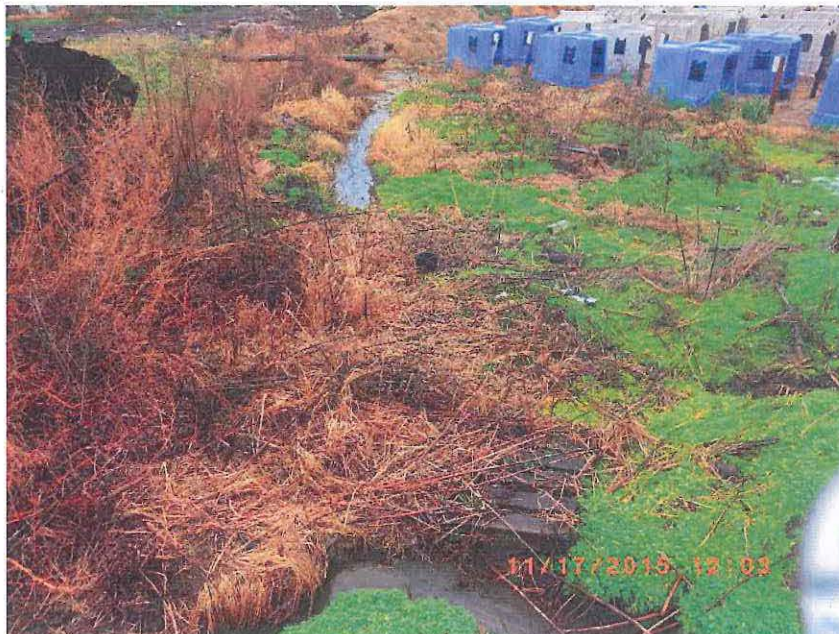
47: RIMG0599

Description: Flow off the calf hutches appeared to flow to the flow channel from the access road.

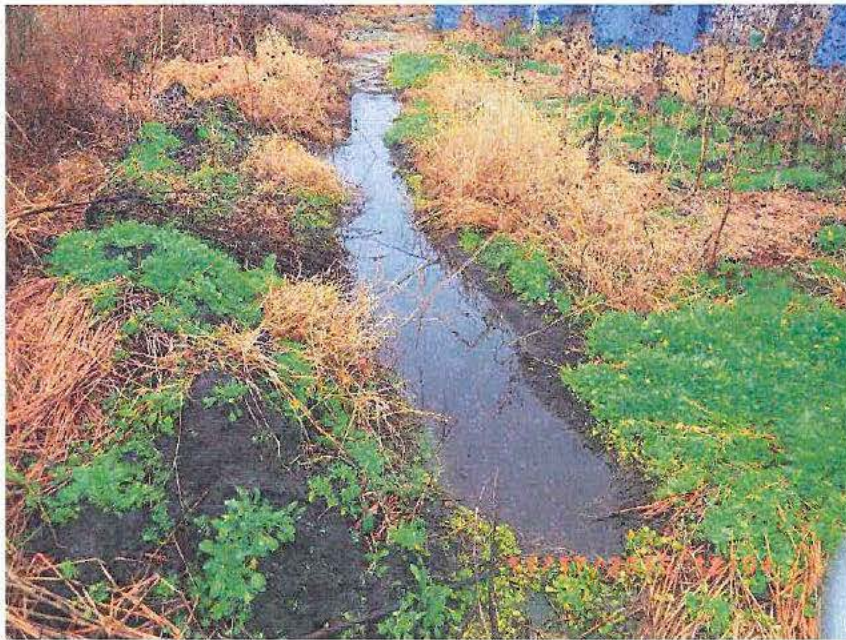
48: RIMG0600

Description: Flow off the calf hutches appeared to flow to the flow channel from the access road.

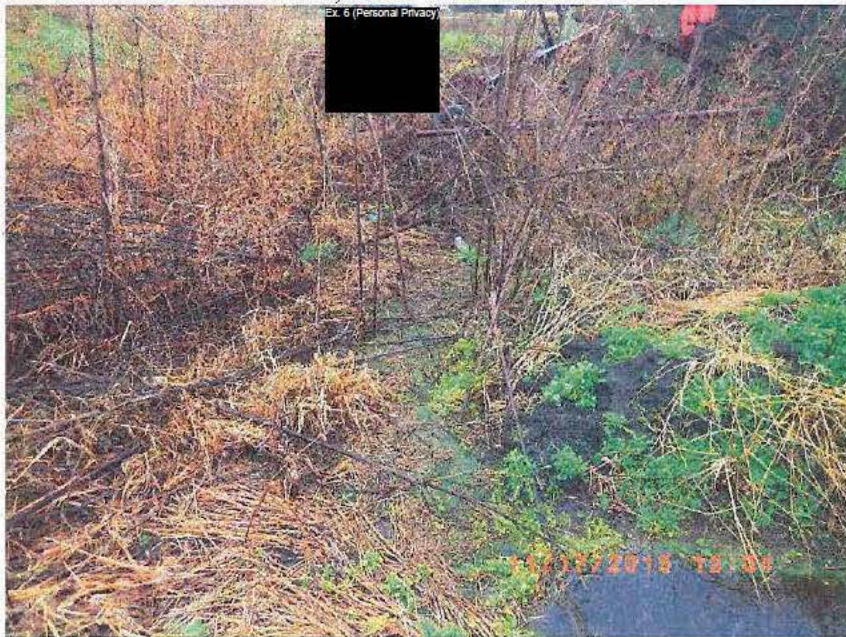
49: RIMG0601

Description: EPA could not confirm a connection between the flow off the calf hutches to the flow channel from the access road due to a pile of debris and equipment.

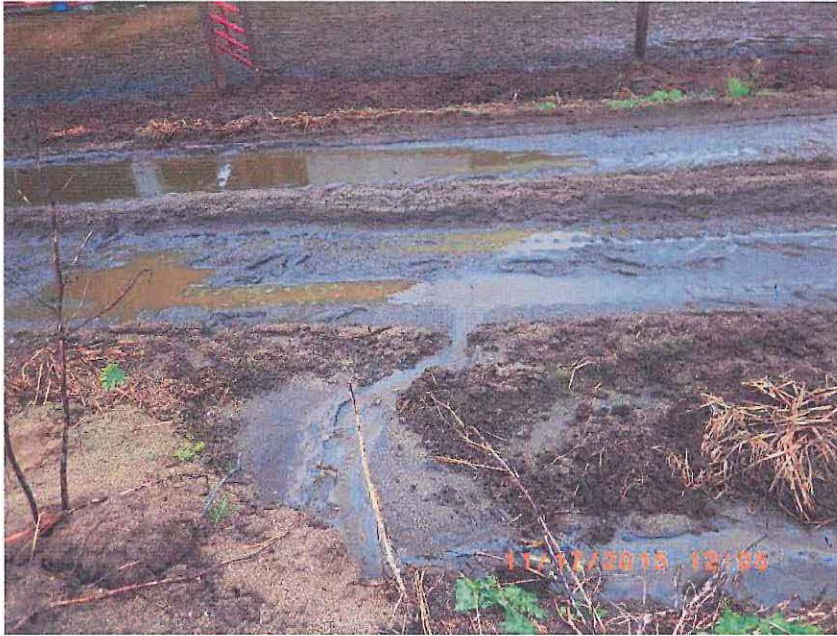
50: RIMG0602

Description: The runoff from the access road has manure and process wastewater in it from the open pens on the west side of the freestall barns.

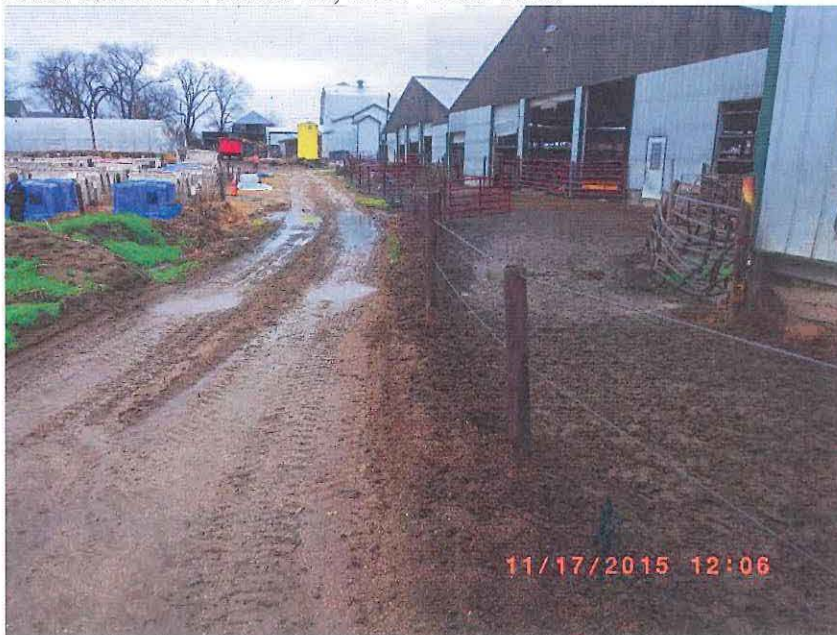
51: RIMG0603

Description: Open pens on west side of the freestall barns do not have containment for manure and process wastewater.

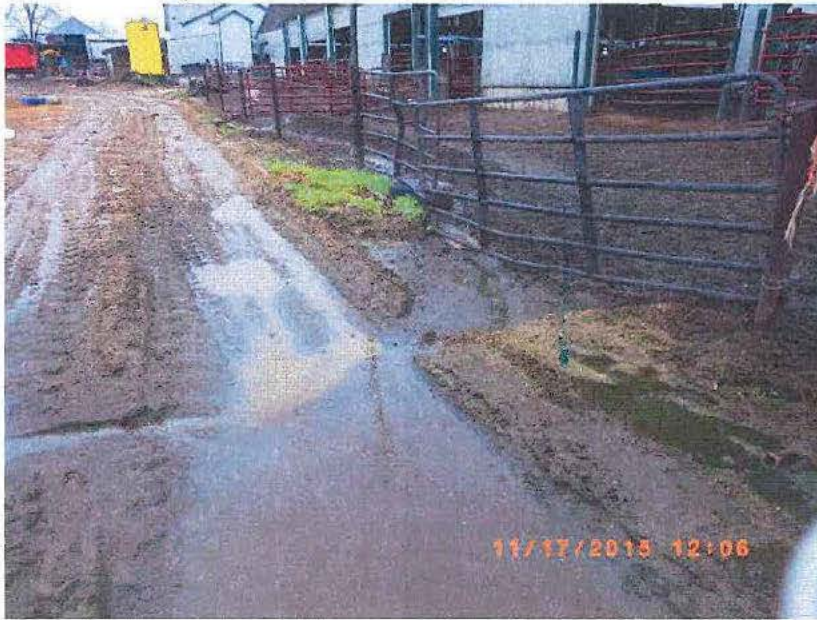
52: RIMG0604

Description: Manure and process wastewater from the open pens west of the freestall barns flows with precipitation to the channel west of the access road. From there it flows south and joins the drainage ditch that flows west.

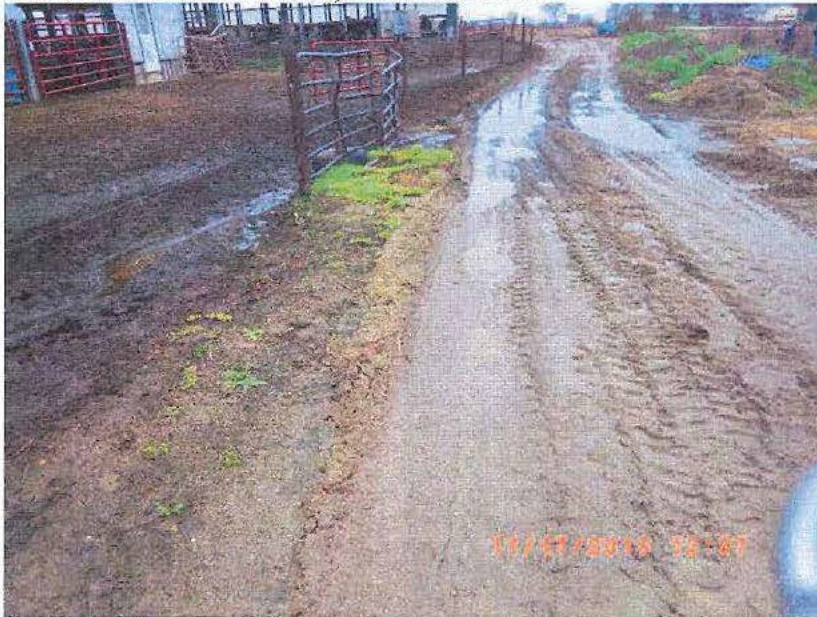
53: RIMG0605

Description: No containment for the manure and process wastewater in the open pens west of the freestall barns.

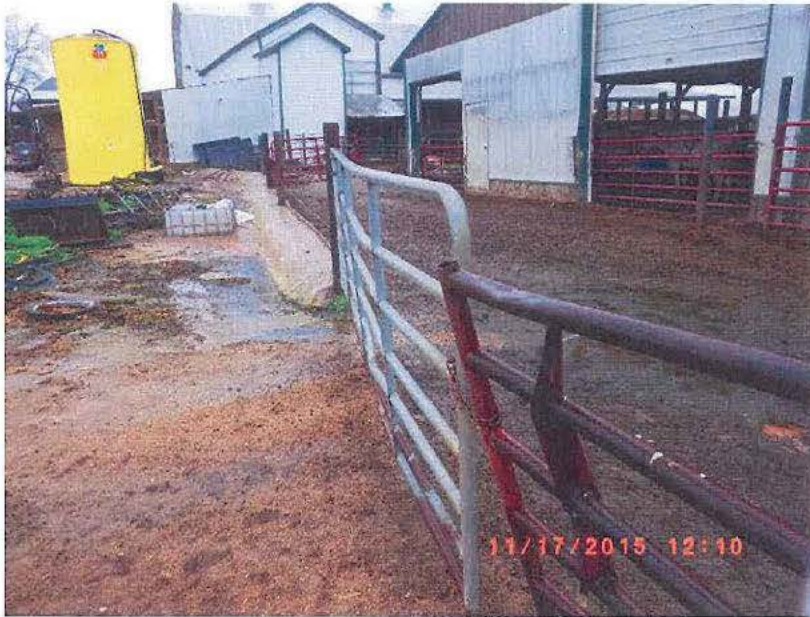
54: RIMG0606

Description: Concrete curbing west of the 2000 Freestall Barn prevents manure and process wastewater from the open pens from flowing to the west. There is nothing to prevent it from flowing to the south and out of the pen, though.

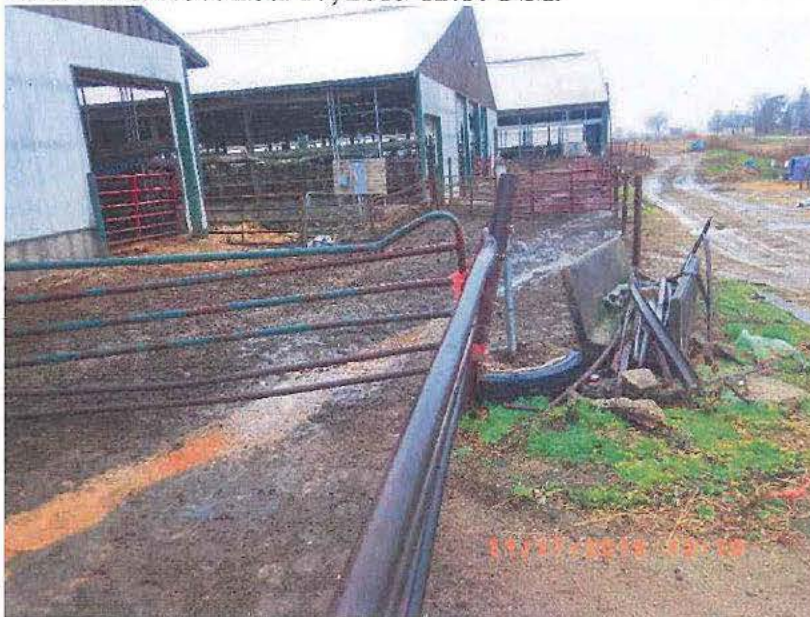
55: RIMG0607

Description: Channelization of manure and process wastewater from open pen west and north of the 2000 Freestall Barn to the south.

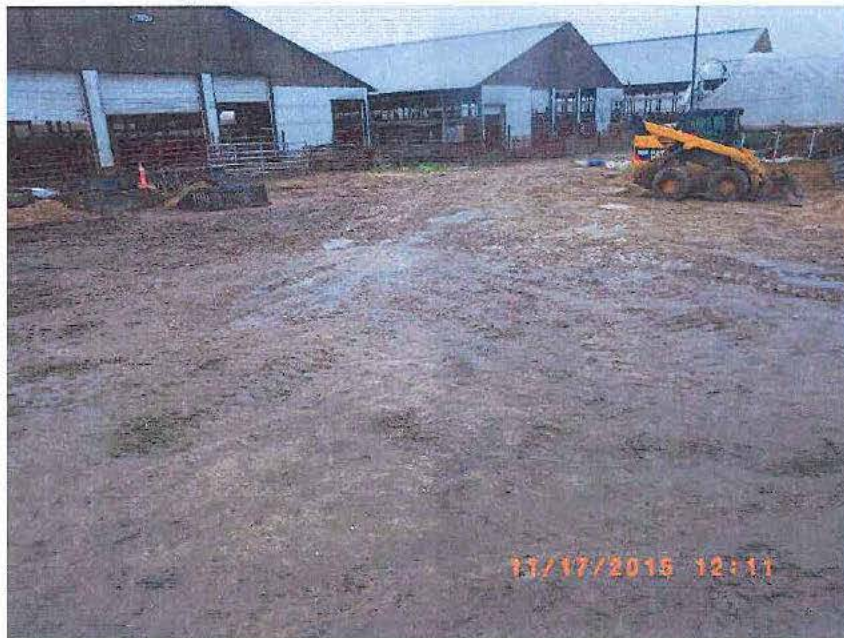
56: RIMG0608

Additionally, feed is mixed on in the space just to the west of the 2000 Freestall Barn. EPA observed spilled feed on the ground which would be transported by precipitation to the south and to this channel and then to the drainage ditch.

Description: Open pens west of the freestall barns do not have any containment for manure and process wastewater. Feed mixing takes place in this area and spilled feed is also able to be transported with precipitation to the south.

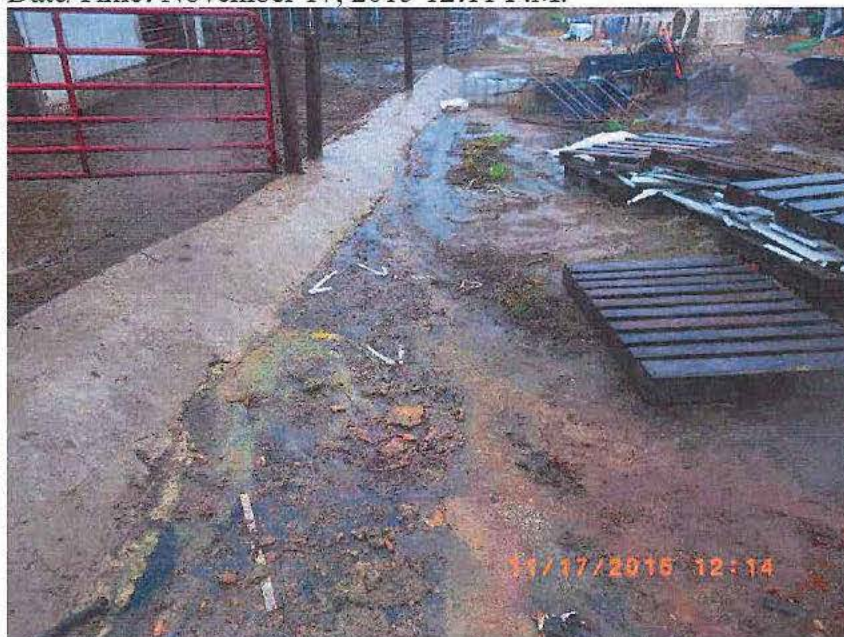
57: RIMG0609

Description: Process wastewater on the ground is transported to the south by precipitation.

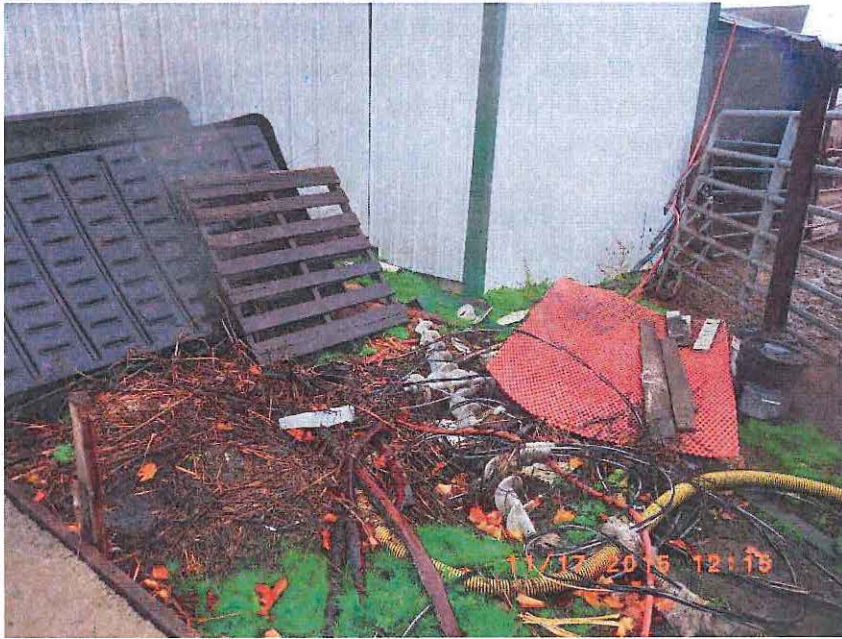
59: RIMG0611

EPA observed three pipes in the space between the 2000 Freestall Barn and the Milking Parlor. The pipes discharge storm water from various locations. One pipe is connected to the area where the milk truck parks, one is connected to a sump pit for storm water inside the Milking Parlor and one is from roof water and is tied to a downspout.

Description: Pipe behind pallet discharges roof water.

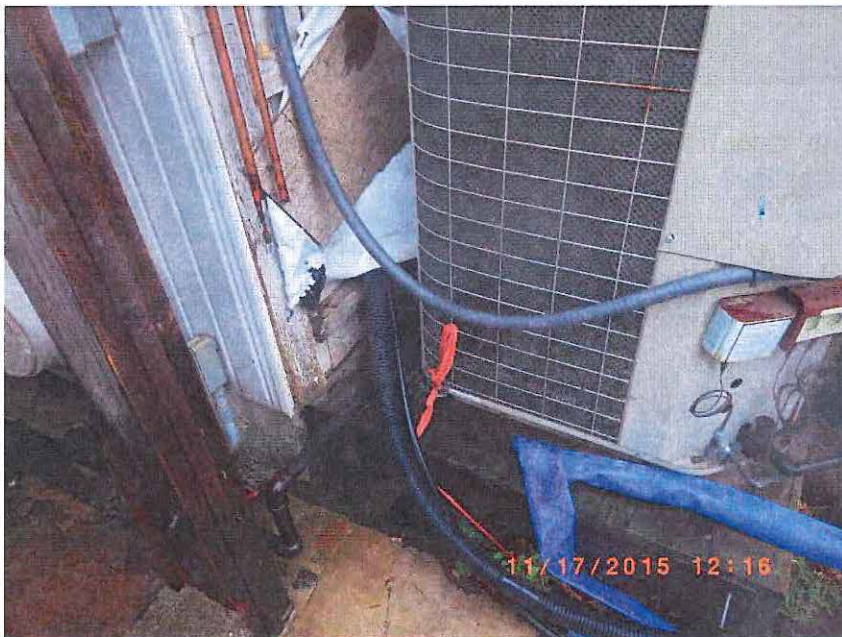
60: RIMG0612

Description: Flexible hosing from sump pit discharges storm water to white pipe.

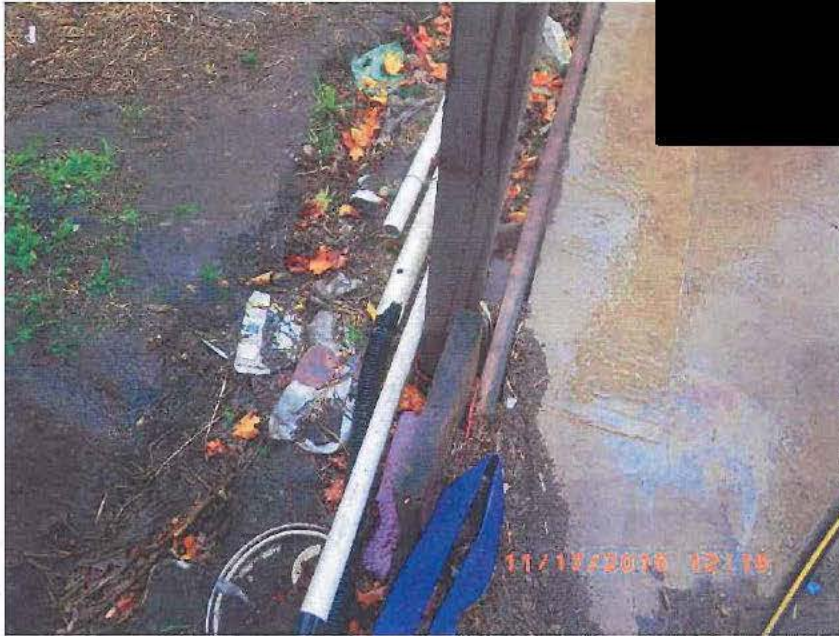
61: RIMG0613

Description: Flexible hosing from sump pit discharges storm water to white pipe.

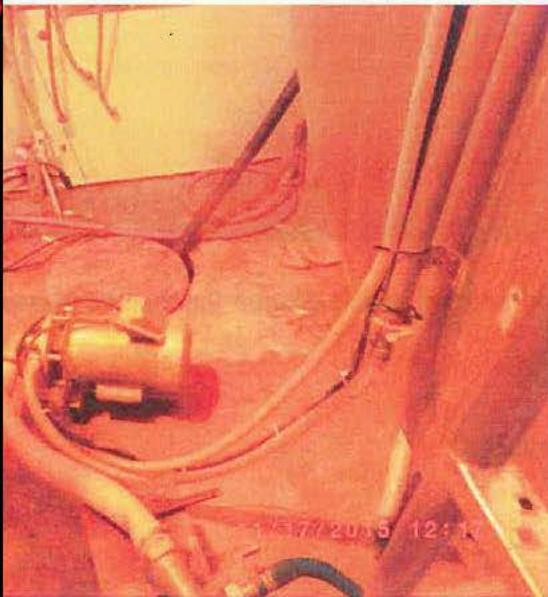
62: RIMG0614

Description: Sump pit with pump for storm water.

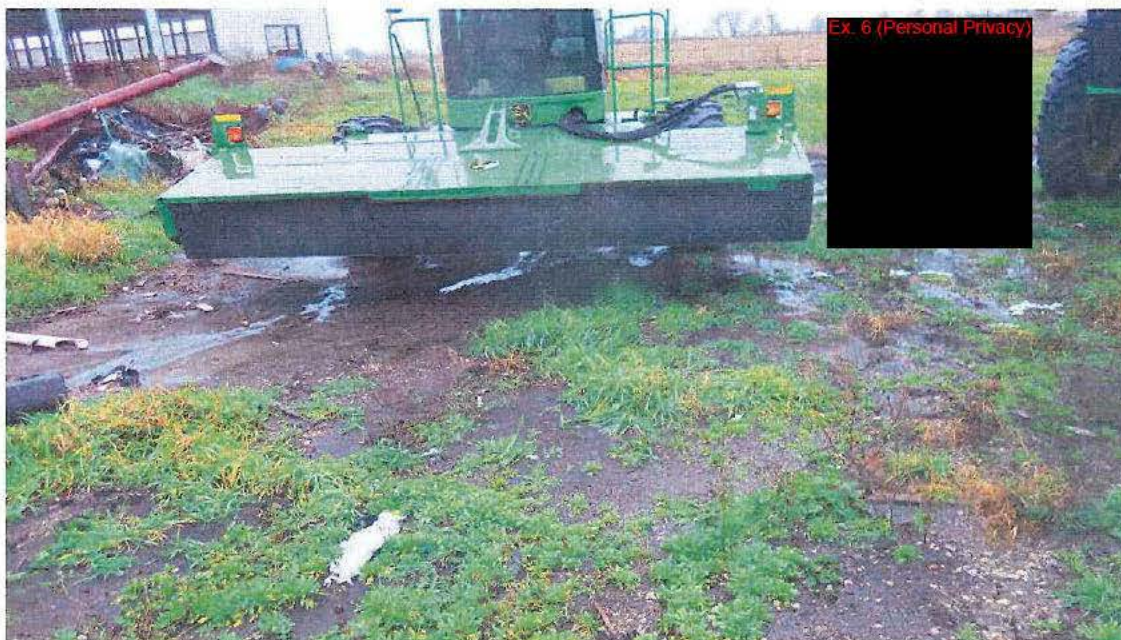
70: RIMG0622

Some of the spilled feed in the feed mixing area flowed to the south in a different pathway, one that flowed between the calf hutches and the building to the west. EPA noted that the standing water was dark colored and truck tire ruts assisted the flow by creating channels. At times, there was not any flow, but the vegetation along the pathway appeared to be nutrient burned and the nutrient burned vegetation led to the drainage ditch.

Description: EPA followed the flow pathway from the feed mixing area to the south between the calf hutches and the building.

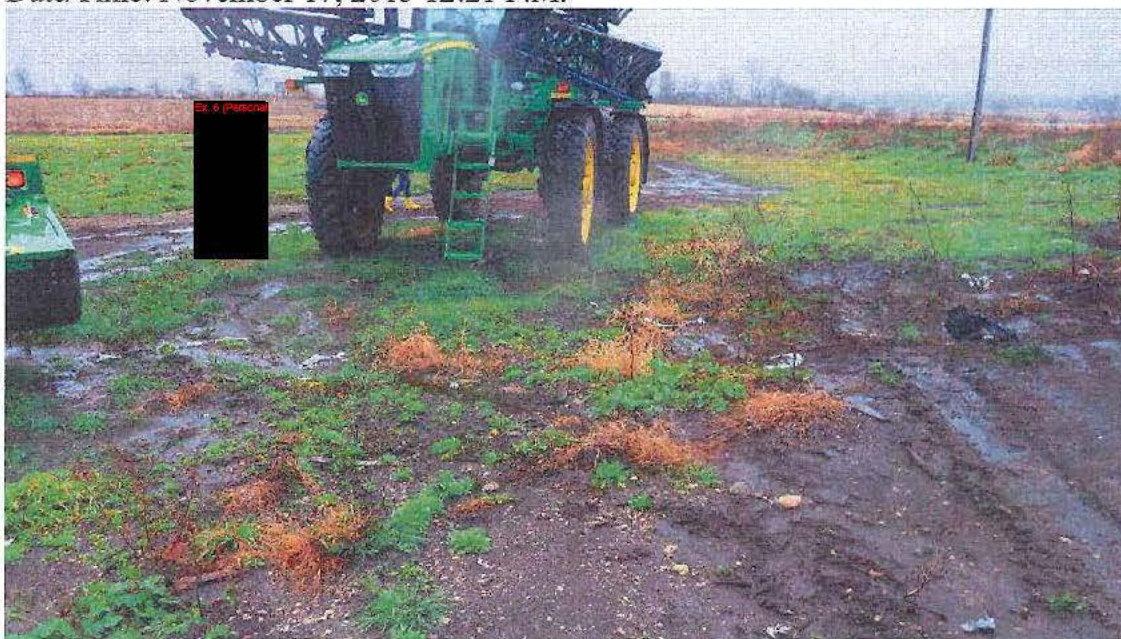
71: RIMG0623

Description: EPA followed the flow pathway from the feed mixing area to the south between the calf hutches and the building.

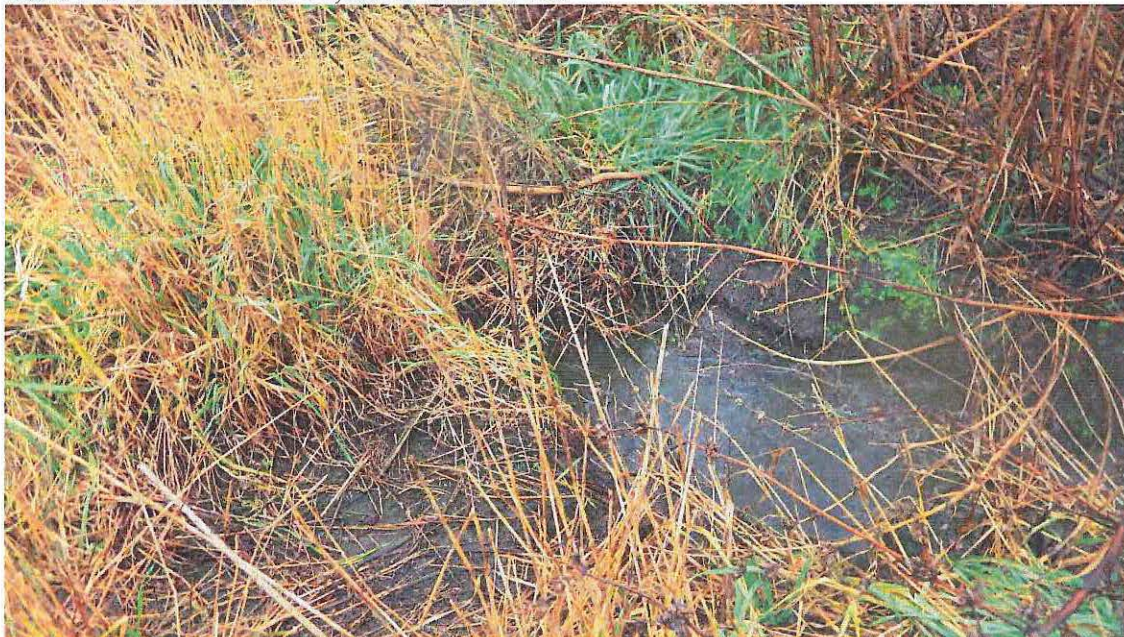
82: RIMG0634

Description: The flow through the culvert under Wisconsin 120 was downstream of the confluence of the flow channel west of the freestall barns and the drainage ditch south of the production area.

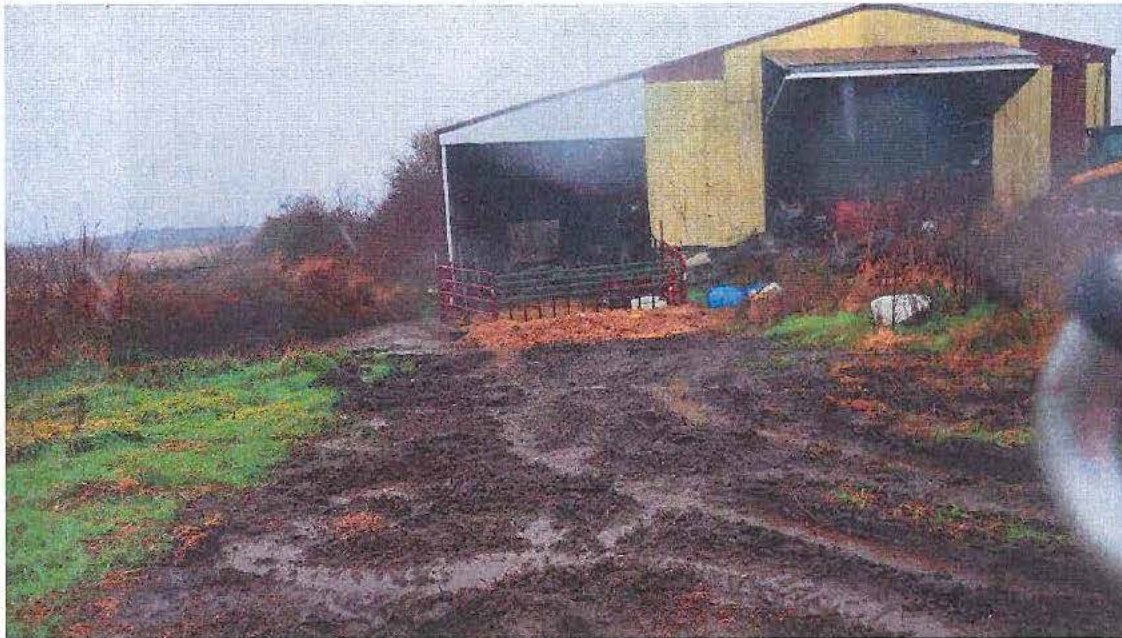
104: RIMG0657

On the west side of Highway 120, there is a storage building with a small area attached that confined a few cattle. Several grain bins and two small heifer barns were also located on this part of the facility. EPA walked to the storage building first and observed that there was no containment for manure, feed or process wastewater from the animal confinement section. EPA documented a runoff pathway from this barn to the south toward the grassed waterway. EPA did not observe this runoff reach a surface waterway on the day of the inspection.

Description: The south side of the Storage Shed on the west side of Wisconsin 120. There is no containment for manure and process wastewater from the cattle confined here.
